# **Low Fill Troubleshooting**

**This guide will help you identify problematic Fill Head components or Pneumatics related to persistent low fills on the CCL-45.**

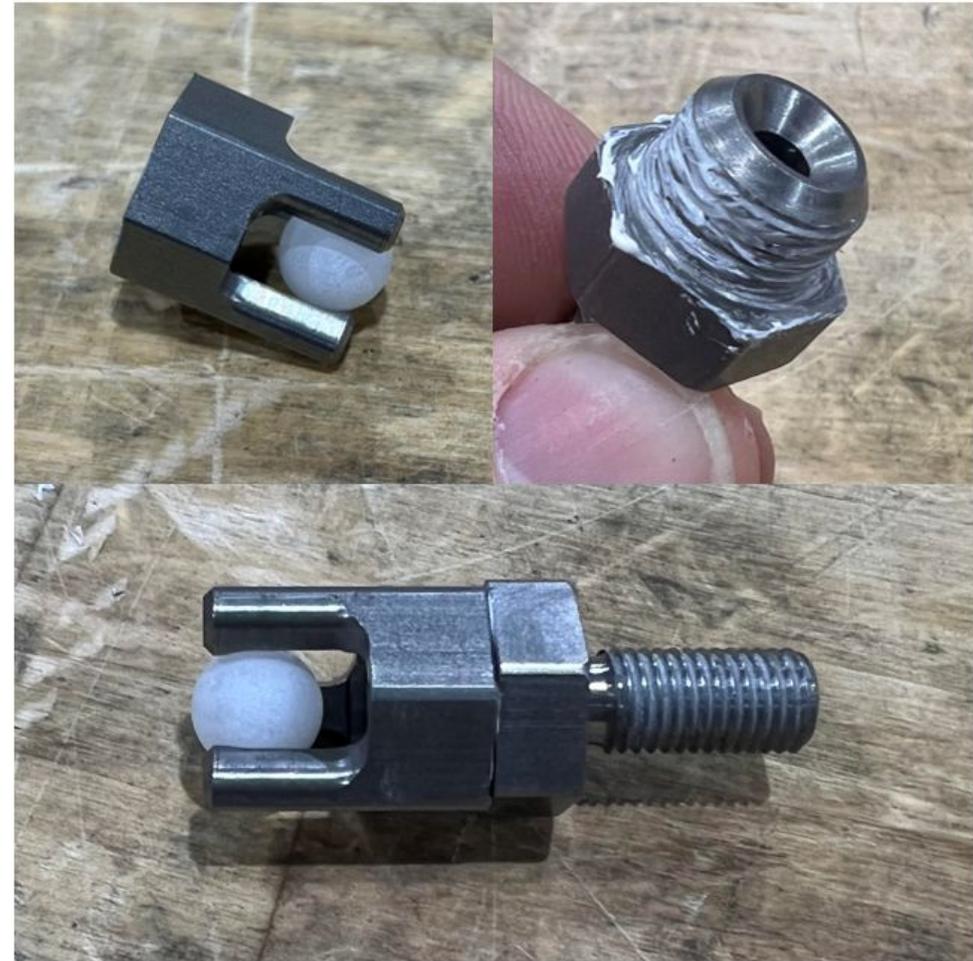
# Swap the Float Ball & Claw Assembly

We like to swap these before replacing them outright because they can fail without visual or mechanical verification. However, a simple swap from the problematic Fill Head to another Fill Head running properly can cause the issue to jump clearly and immediately.

The problem can also be tied to the female thread on the CO2 Vent Stem that the Float Claw connects to. These can be easily cross-threaded, so carefully loosen them by hand once they've been broken free using a 5/8" Deep Well Socket. Re-tighten by hand and finish tightening with the Socket Wrench.

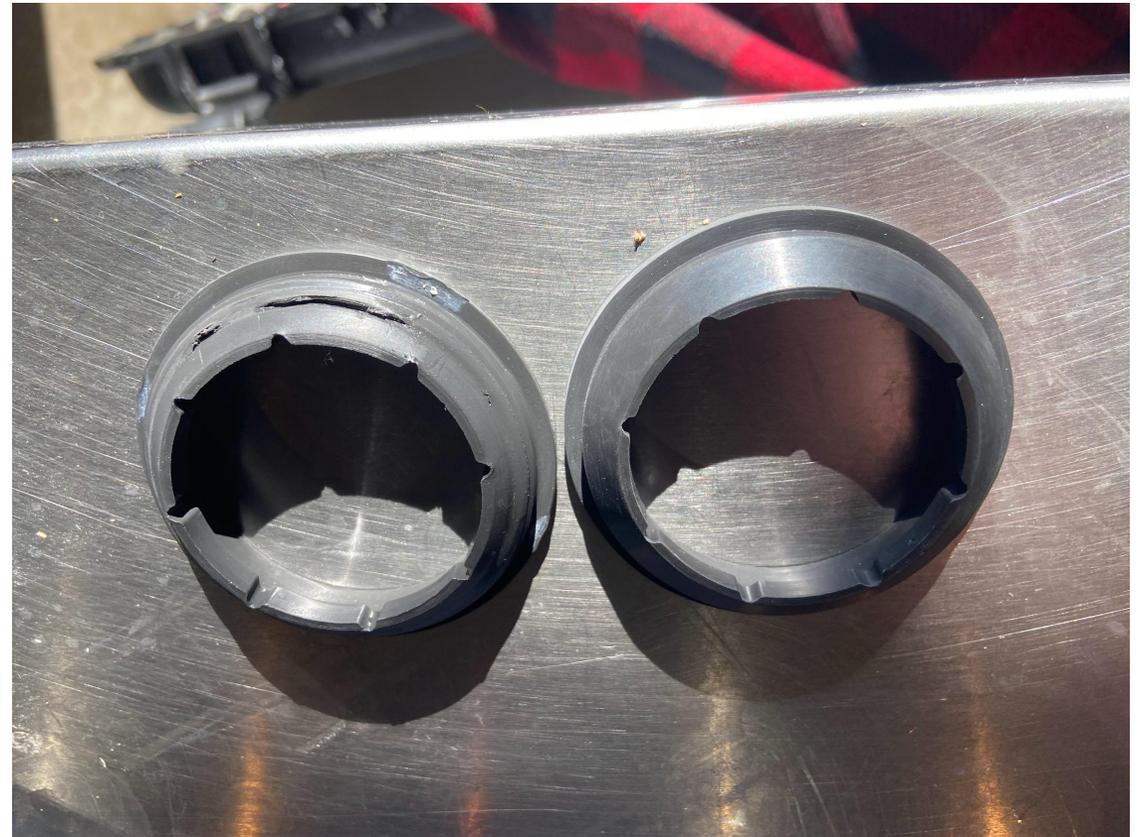
# Swap the Can Seal Gasket

If there is a tiny imperceptible leak in the problematic Fill Head, it will essentially act like there is a slightly higher Throttle setting - the gas is leaking out while it is also flowing out under control using the Throttle so there is slightly more total gas flow. As you know, higher Throttle will lead to more foam and a slightly lower fill level.

Loosen the 4 7/16" bolts holding the Fill Head to the Carriage, and remove the Centering Bells out from under the Fill Heads. Swap the Gaskets between the problematic Fill Head and one producing good fills to see if the problem follows.

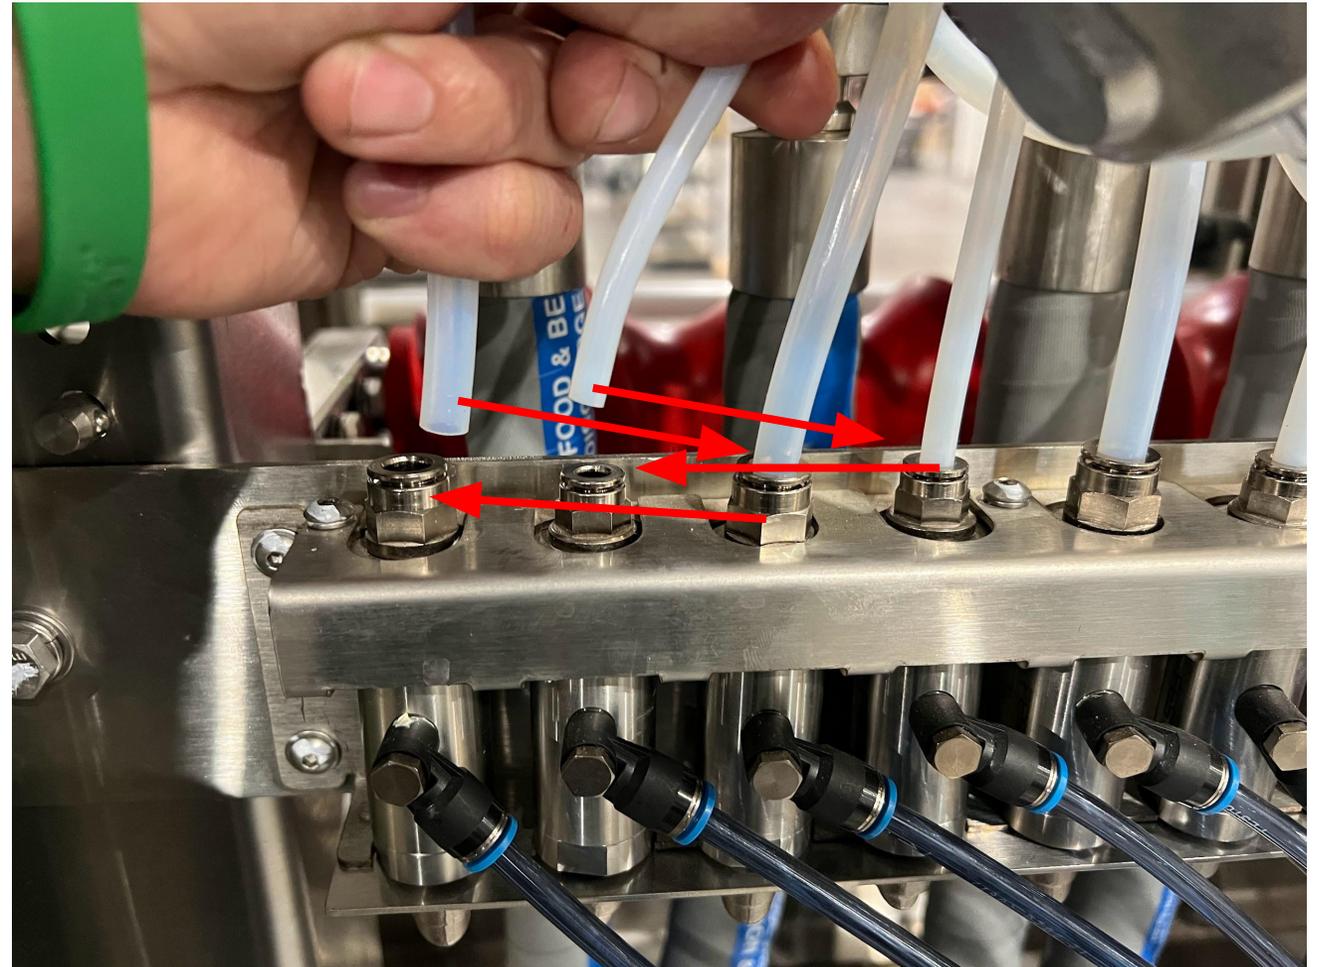
# Swap the Throttle and Snift Lines

These lines are utilized during the Throttle and Snift processes.

For this step, simply disconnect the 8mm and 6mm tubes that control the Throttle and Snift at the top of the Pinch Valves of the problematic Fill Head.

Switch them with the matched set on a Fill Head filling consistently and see if the problem follows.

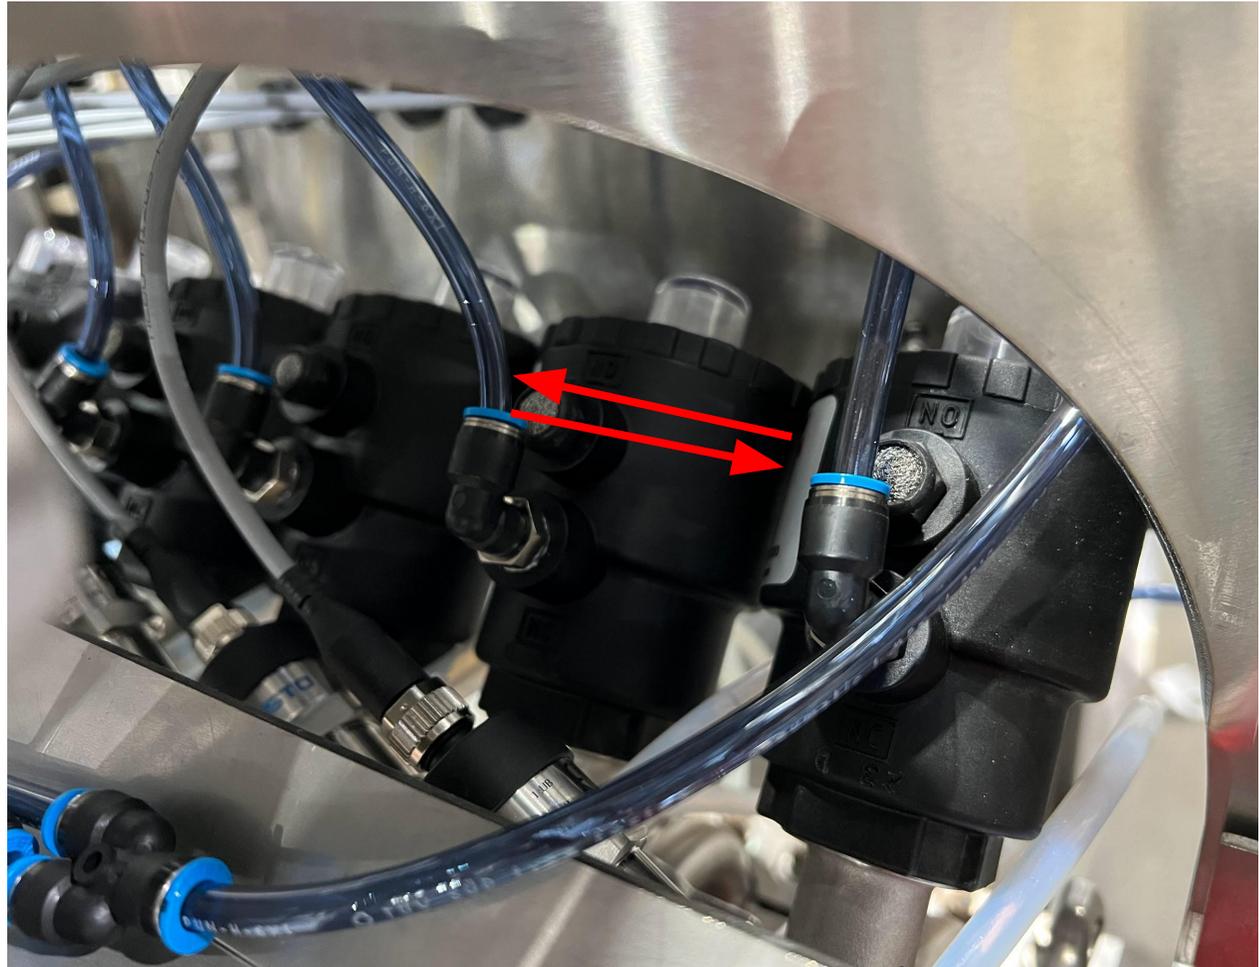
# Swap the Angle Seat Valve Air Line

The Pilot air lines open and close the Angle Seat Valves, controlling the stop and start of product flow into the Fill Heads.

Swap the 6mm air line that connects to the Angle Seat Valve from the problematic Fill Head to one filling consistently to determine if an Angle Seat Valve needs to be replaced.

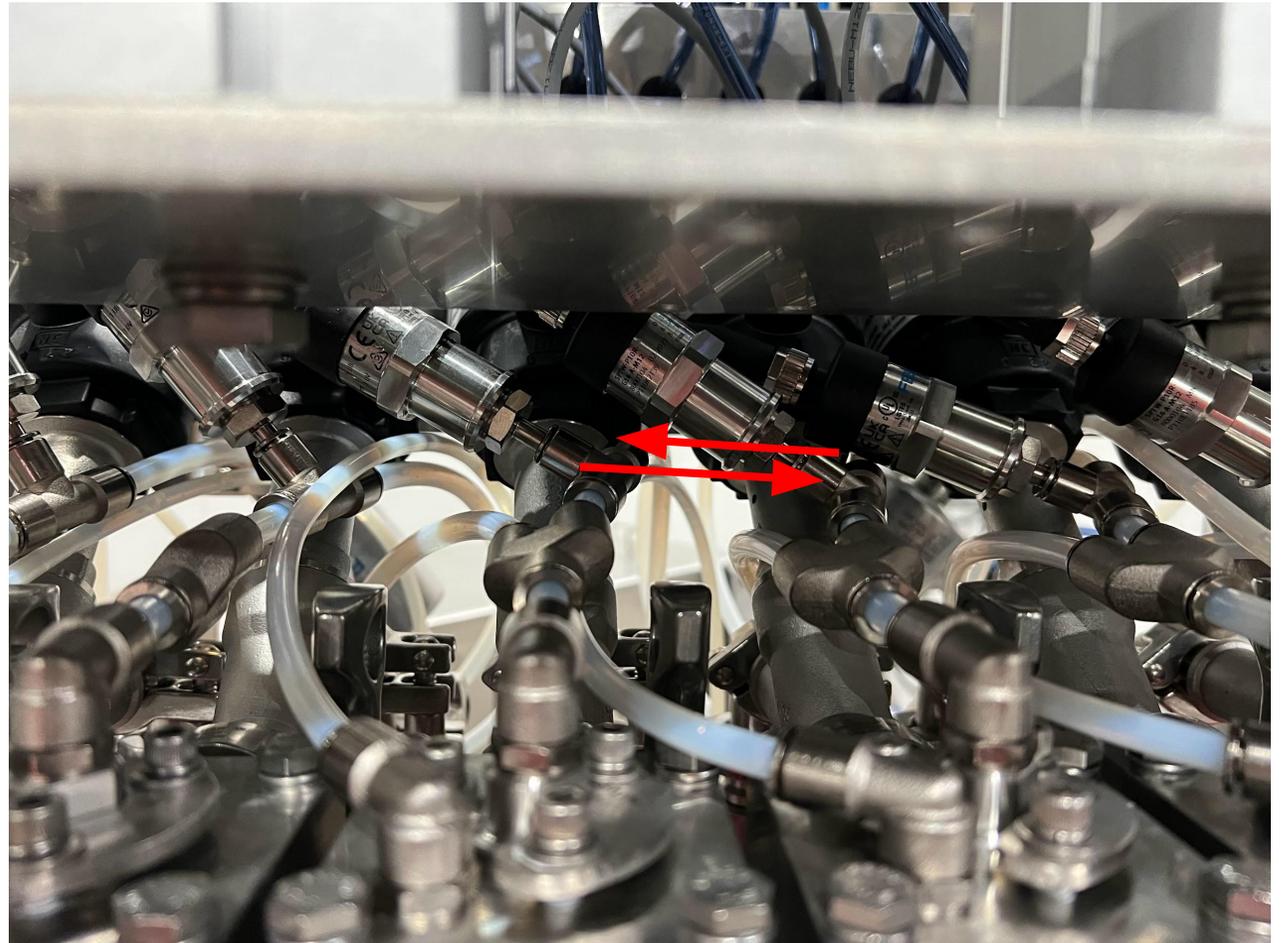
# Swap the Pressure Transducer

The Pressure Transducer measures CO2 pressure inside the Fill Head loop.

The pressure inside the cans is equalized during the fill cycle, so while this should not have much effect and is more difficult to visually confirm, it is part of the fill loop and is worth explicitly ruling out.

Remove the Transducer from the problematic Fill Head T connection and swap with a Transducer from a properly working Fill Head. Note any differences in breakout as well as the individual pressure readouts on the HMI.

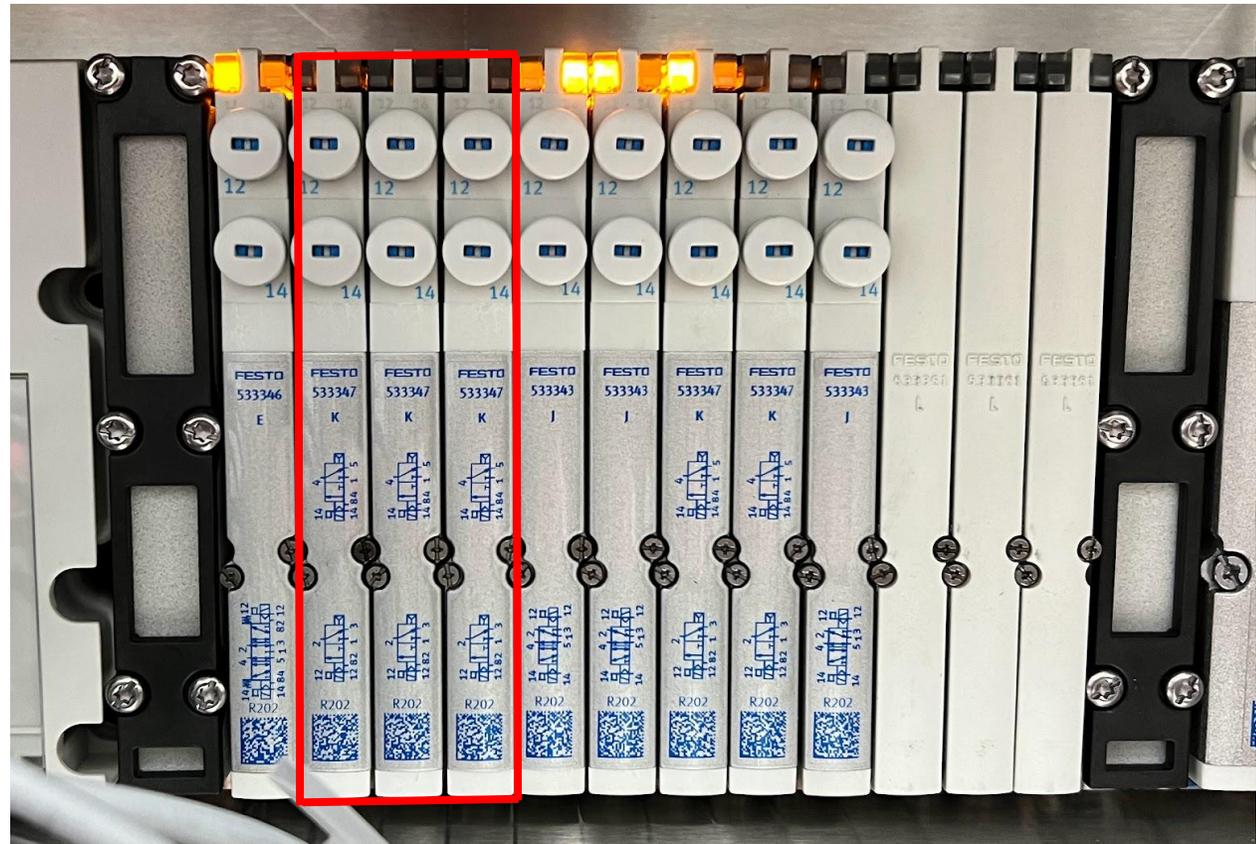
# Swap the Valve Card

On a 6 Head Filler, these three (K) Valve Cards control your Fill Heads.

Each card controls two Fill Heads (L to R - 1 & 2, 3 & 4, 5 & 6).

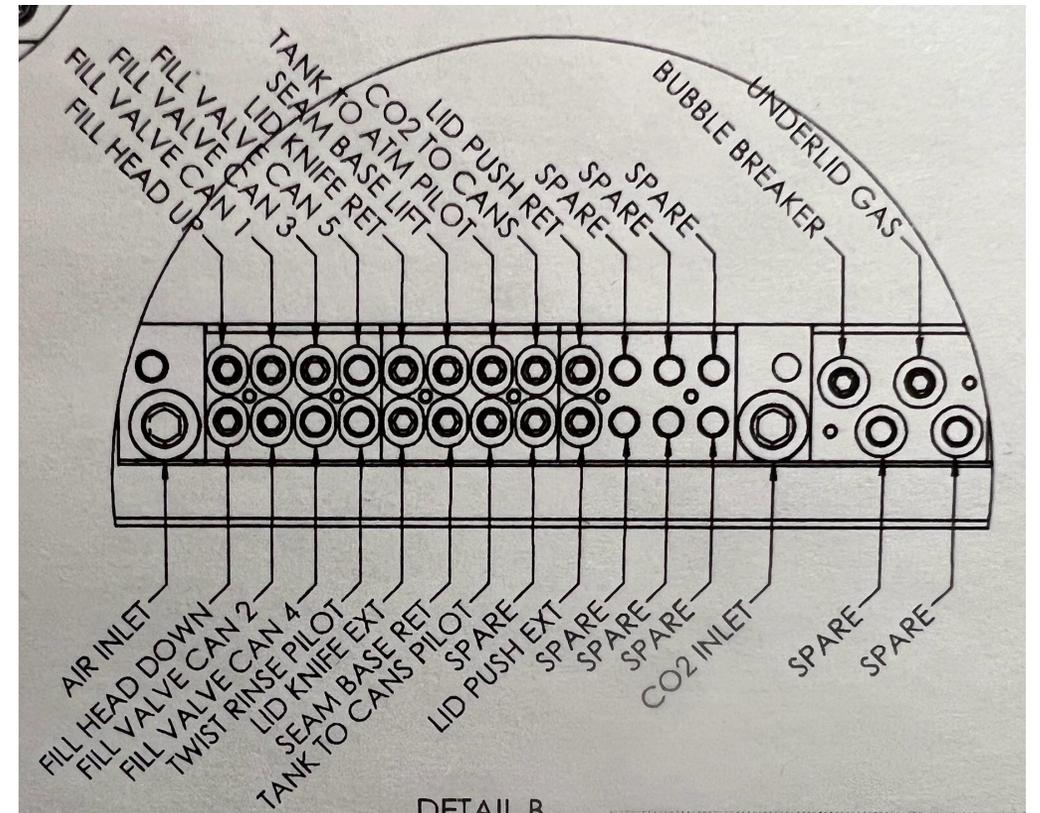
# Swap the Valve Card

Follow the pilot air line back to the Festo Manifold and locate the (K) Valve Card that controls your problematic Fill Head.

Use the diagram provided to locate which Valve Card controls the Fill Head in question.

Verify that the Card you swap also controls two the Fill Heads.

While in the Festo Manifold, look for any signs of oil/water/debris and clean out using aerosolized sterile air (i.e. computer duster). Often times, gunk in the back of the valves is the culprit of sporadic filling by the valves being stuck open.

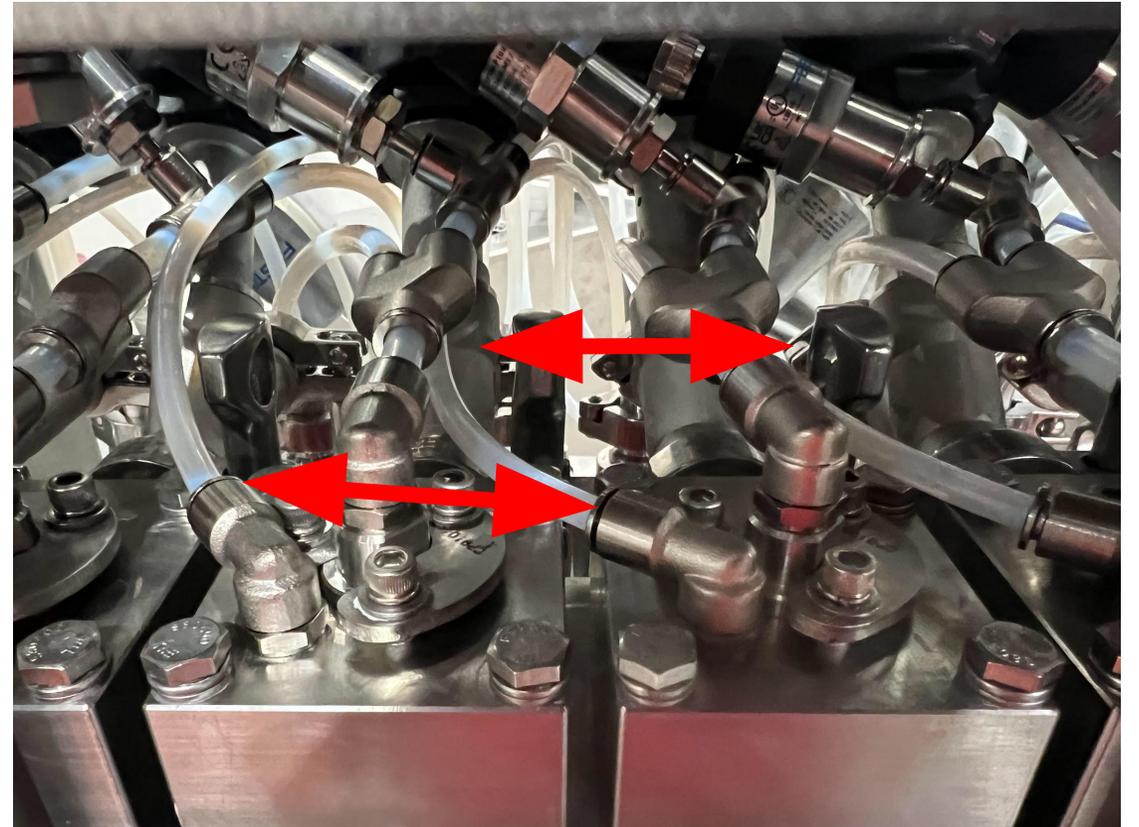
# Swap the Fill Head Tubing

Swap the tubing that connects the top of the Fill Head back to the Snift Valve Manifold. Checking for any rubbing or kinks in these lines can reveal leaks or imperfections that may inhibit throttle or snift controls that contribute to persistent low fills.

Include both 8mm tubes that connect into the Fill Head through the Y-connection - one line goes to the Pressure Transducer and Pinch Valve, the other goes to the shared Manifold for “Tank to Cans” and “CO2 to Cans” - and the 6mm tube that goes from the Fill Head to the Snift Pinch Valve.

It may be worth taking note of the length of the tubing compared to the other Fill heads

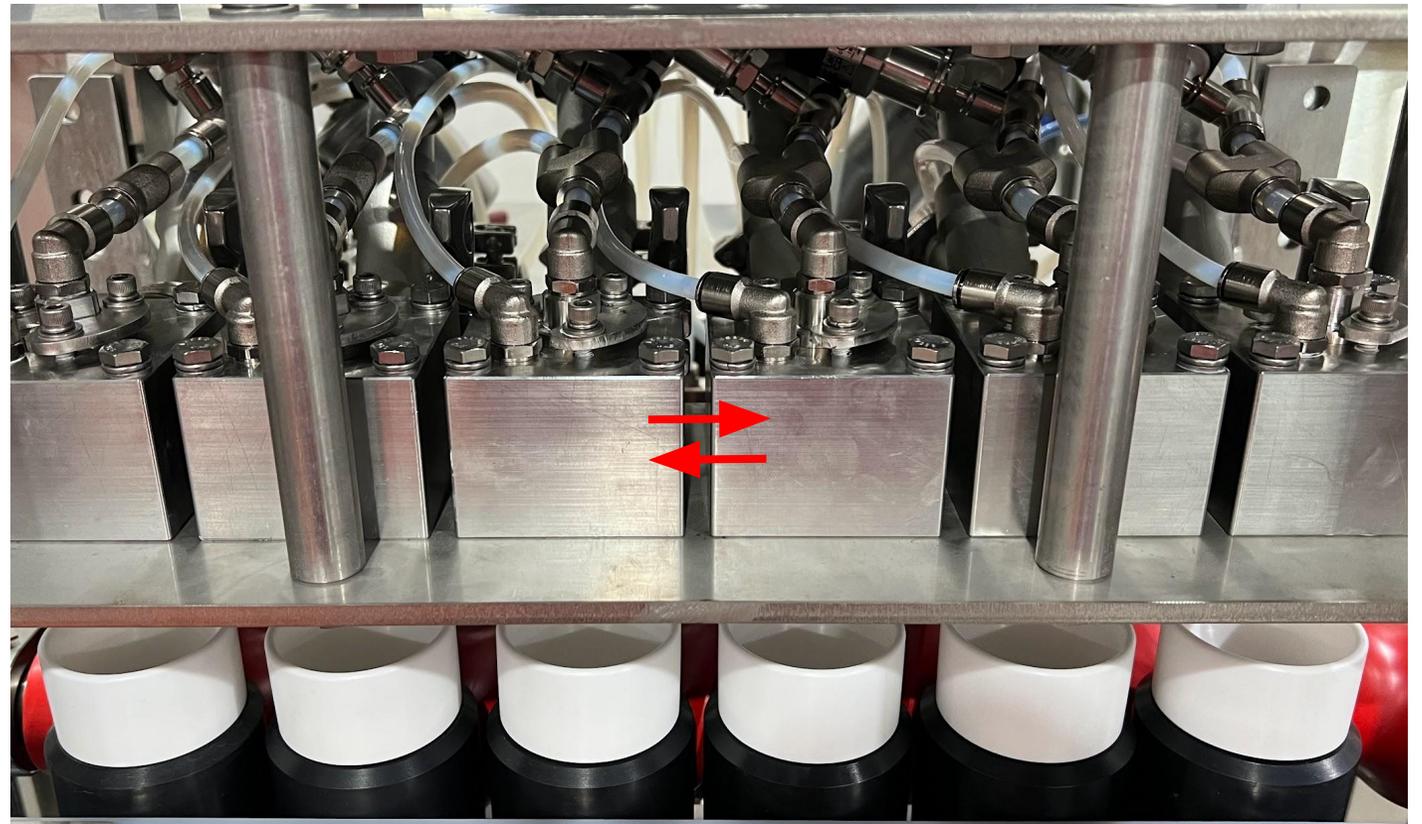
# Swap the Fill Head

This step includes swapping out a few suspect internals of the Fill Head at the same time.

Disconnect the 6mm and 8mm hoses from the push-to connections on top of the Fill Head Blocks. Remove the four 7/16" bolts holding each Block to the frame. Once the bolts have been broken free, remove the Centering Bells on the underside of the Fill Head Carriage, and the Blocks should pull up and out.

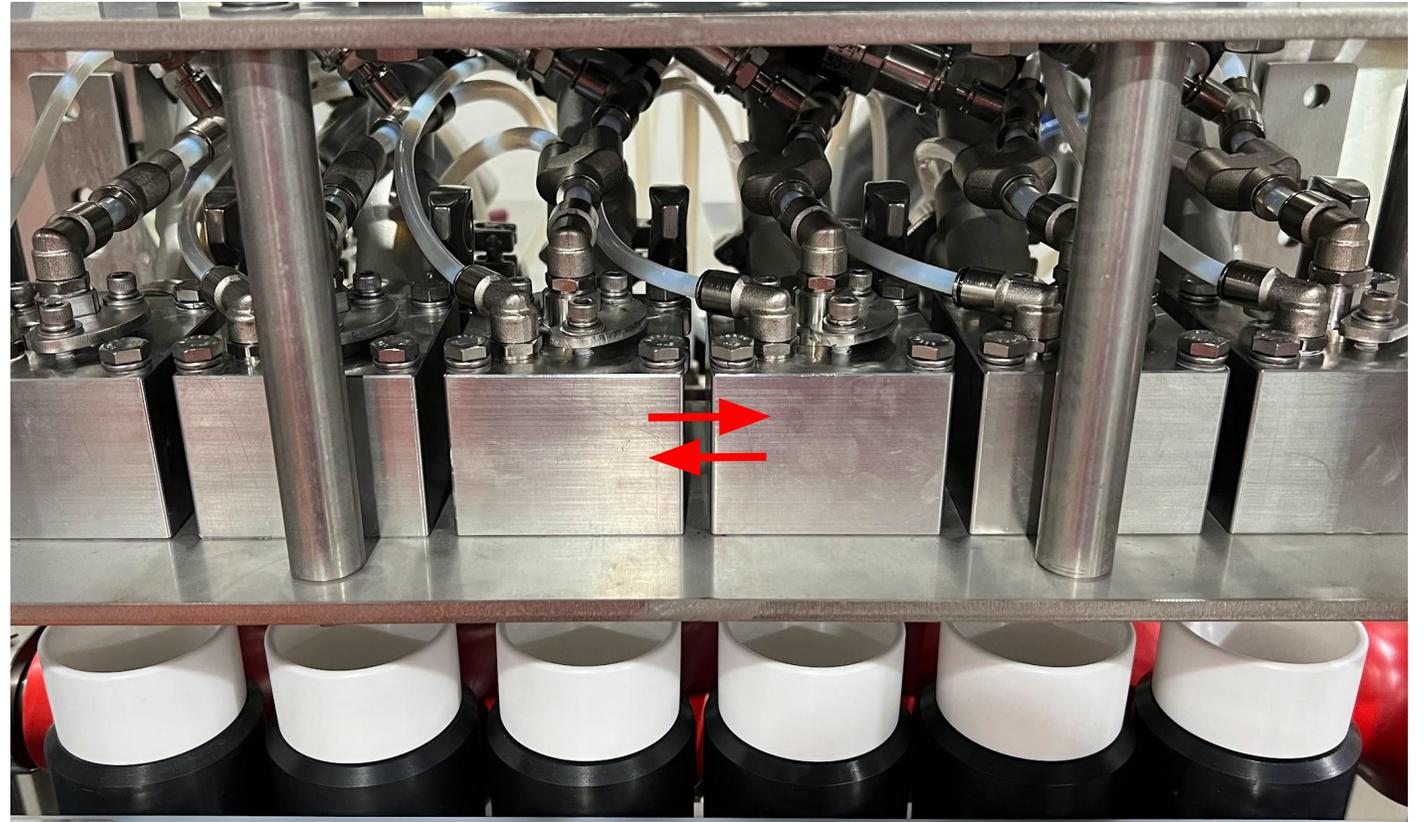
# Swap the Fill Head

If this change is the one that fixes your Low Fill issue, disassemble the Fill Head and check the condition of the other internals (aside from the Float Ball & Claw assembly that was examined previously), such as the CO2 Vent Stem, O-Ring at the top of the Stem, and the Centering Cone.

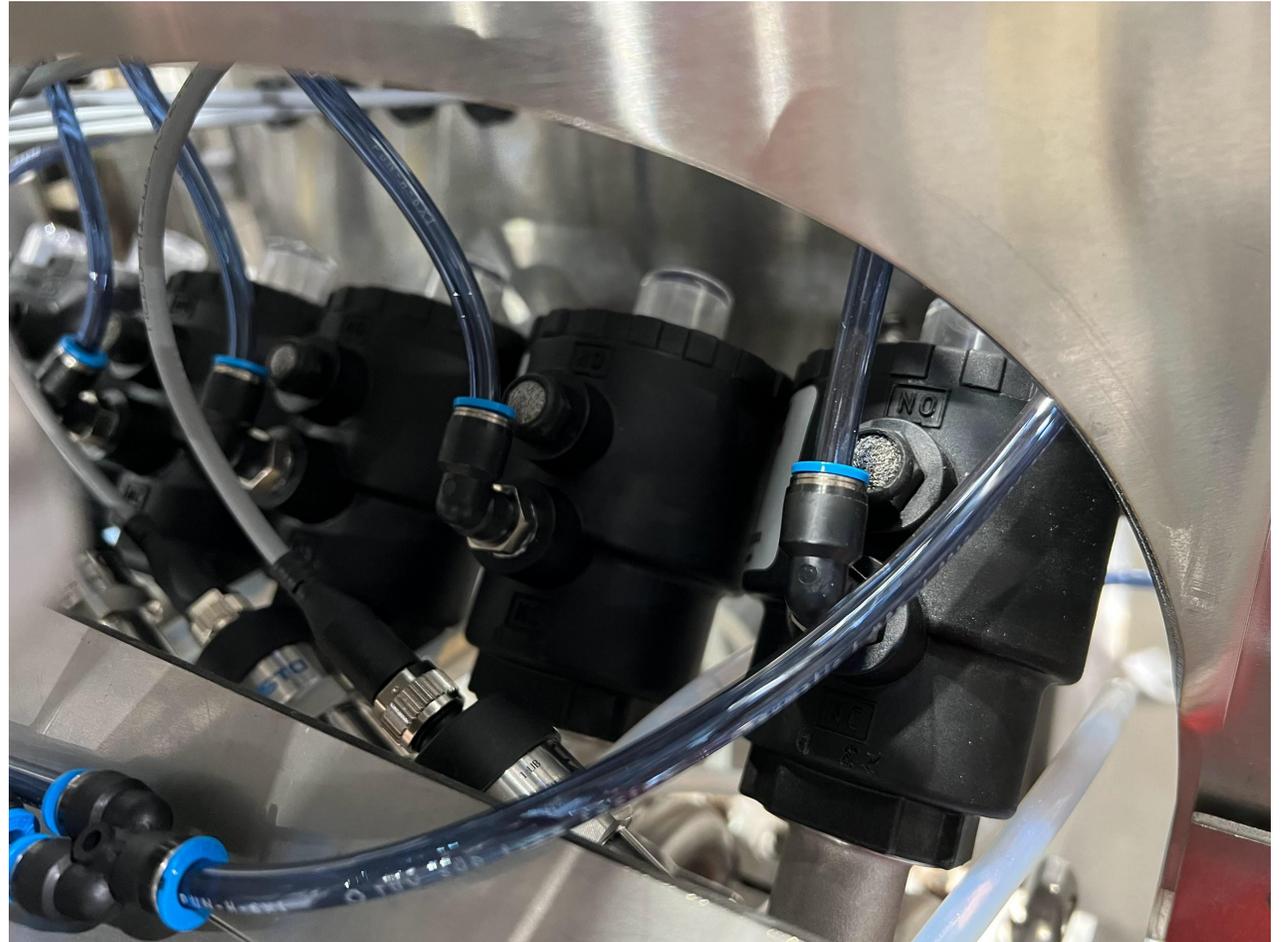
# Swap the Angle Seat Valve

Rather than swapping the pilot air lines completed earlier, this step involves swapping the Angle Seat Valves themselves.

Angle Seat Valves can become faulty without showing signs of internal component failure other than inconsistent filling, so performing this swap may immediately indicate that the Angle Seat Valve is the problem child in the grand scheme of filling components.

For this swap, we typically swap the tri-clamps and gaskets along with the Angle Seat Valve. Examine them for imperfections as well.

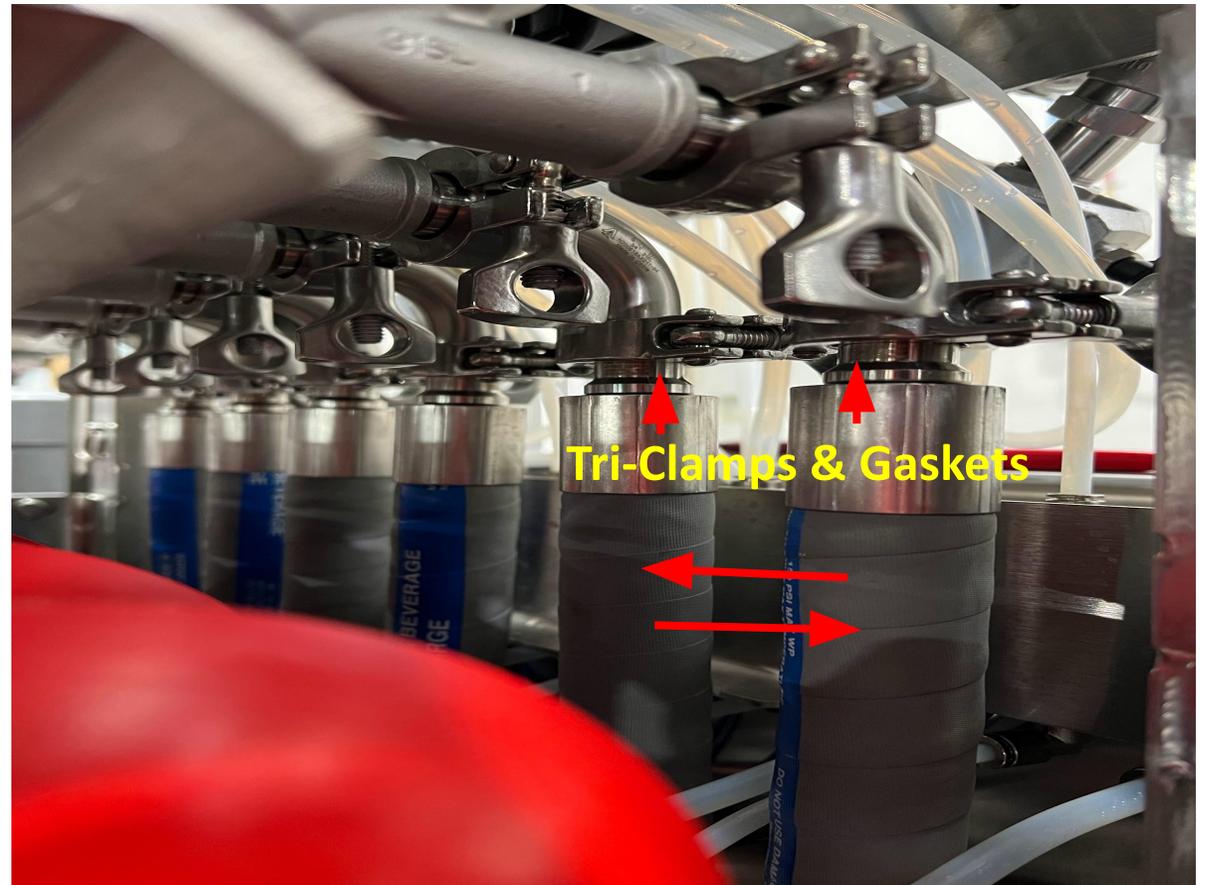
# Swap the Fill Hose, Tri-Clamp and Gasket

While completing this swap, it's worth noting to look carefully at the path of the hose.

Each one takes a slightly different path between the Tank and Fill Heads. A few of them fold up tight against the tank, so it is possible that a kink or some other difference in the product's path may be a contributing factor.

Although the Fill Hoses are factory cut and crimped, it may be worth evaluating the length of the hose compared to the others to determine an outlier.

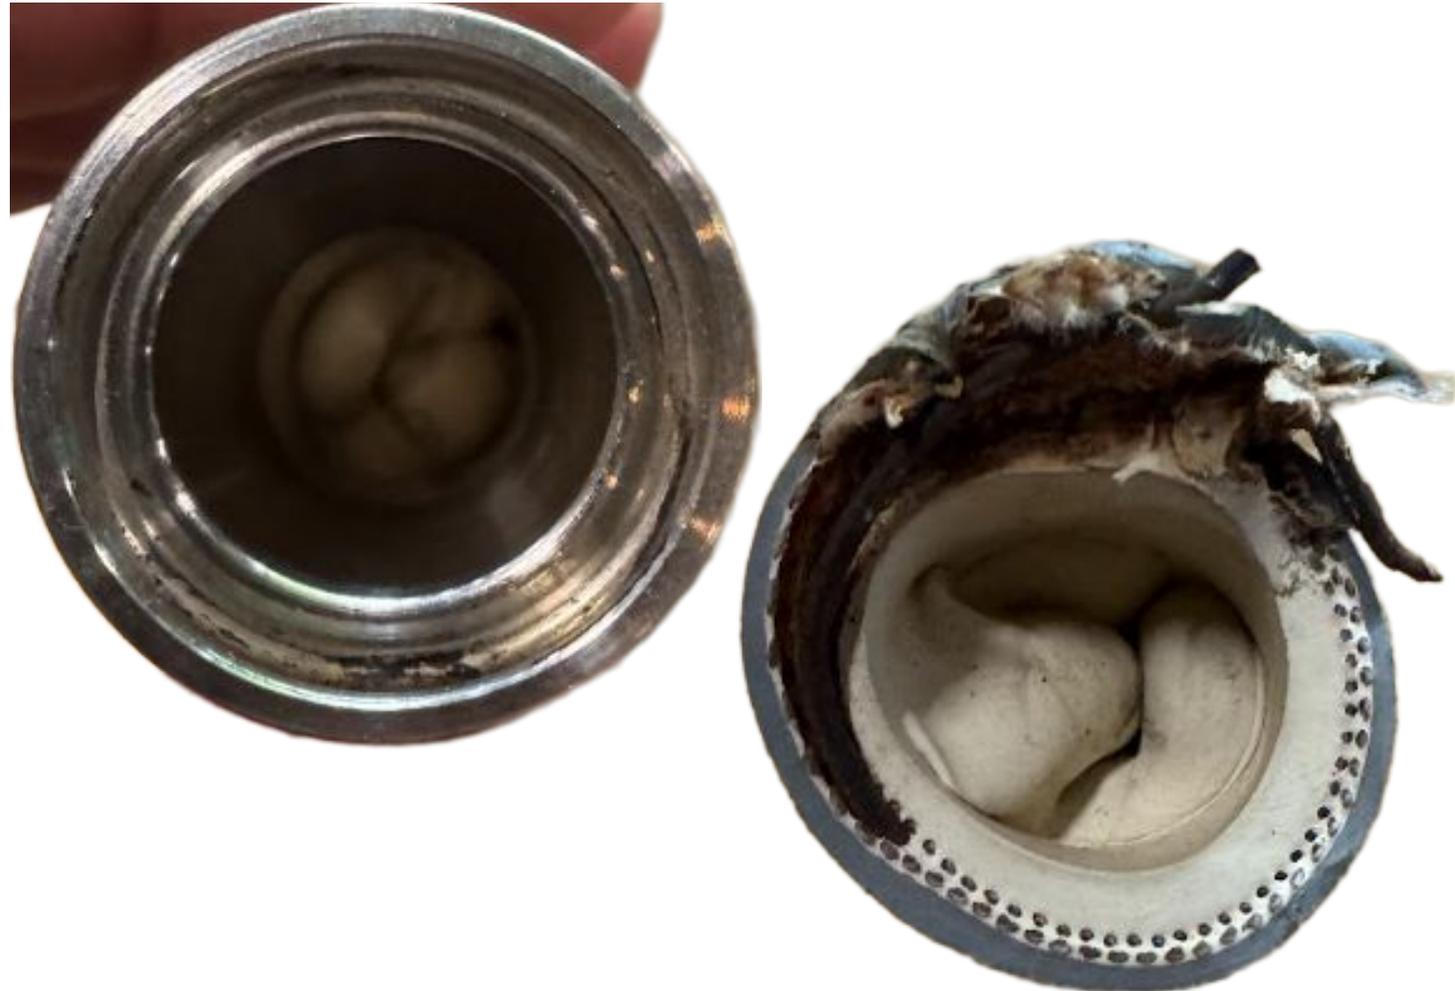
# Check product hose ferals for bulging

This issue is not super common, but it is worth checking to see if there is any internal bulging of the hose.

The pictures to the left show a most extreme case, but you don't have to go to math college to figure out that if the product flow is choked off by a bulged hose, it is going to greatly affect our fill levels.

The only true fix here is a swap to a new product hose: Part #XP002197
